Failures in Hybrid Microcircuits during Environmental Testing. History cases.

Alexander Teverovsky

Perot Systems/NASA GSFC, code 562, Parts, Packaging,
and Assembly Technologies Office
Alexander.A.Teverovsky.1@gscf.nasa.gov

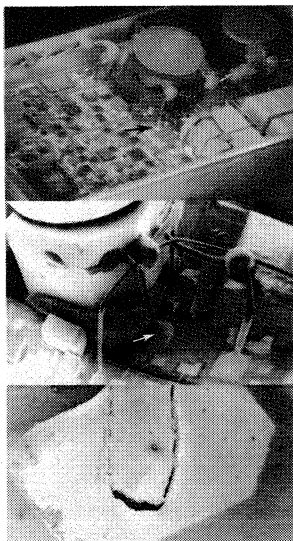
Case II. Flex-Lid-Induced Failures.

- A DC-DC converter failed during box-level testing in a thermo-vacuum chamber.
- The failure was due to a soldered joint fracture.
- Failed wire was secured to the transformer fixed to the lid with silicone.
- Mechanism of failure: low-cycling fatigue caused by deformation of the lid and shifts of the transformer and wire.

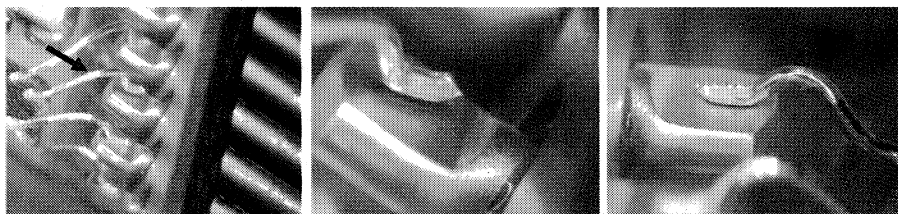
Case V. Wire Bond Failures.

- Five hybrid solid state power controllers successfully passed life testing at 125 °C during 1000 hours.
- Additional electrical measurements after testing unexpectedly revealed open pins in two parts.
- The failures were caused by lifted 10-mil Al wires.
- Although Al wires are annealed, they are stiff and have built-in mechanical stresses, which might result in failures in bonds with weakened adhesion under minor mechanical disturbances.
